CONNECTICUT RIVER BASIN
SOUTH BARRE, MASSACHUSETTS

SOUTH BARRE MILL POND DAM
MA 00091

PHASE I INSPECTION REPORT
NATIONAL DAM INSPECTION PROGRAM

AUGUST 1978

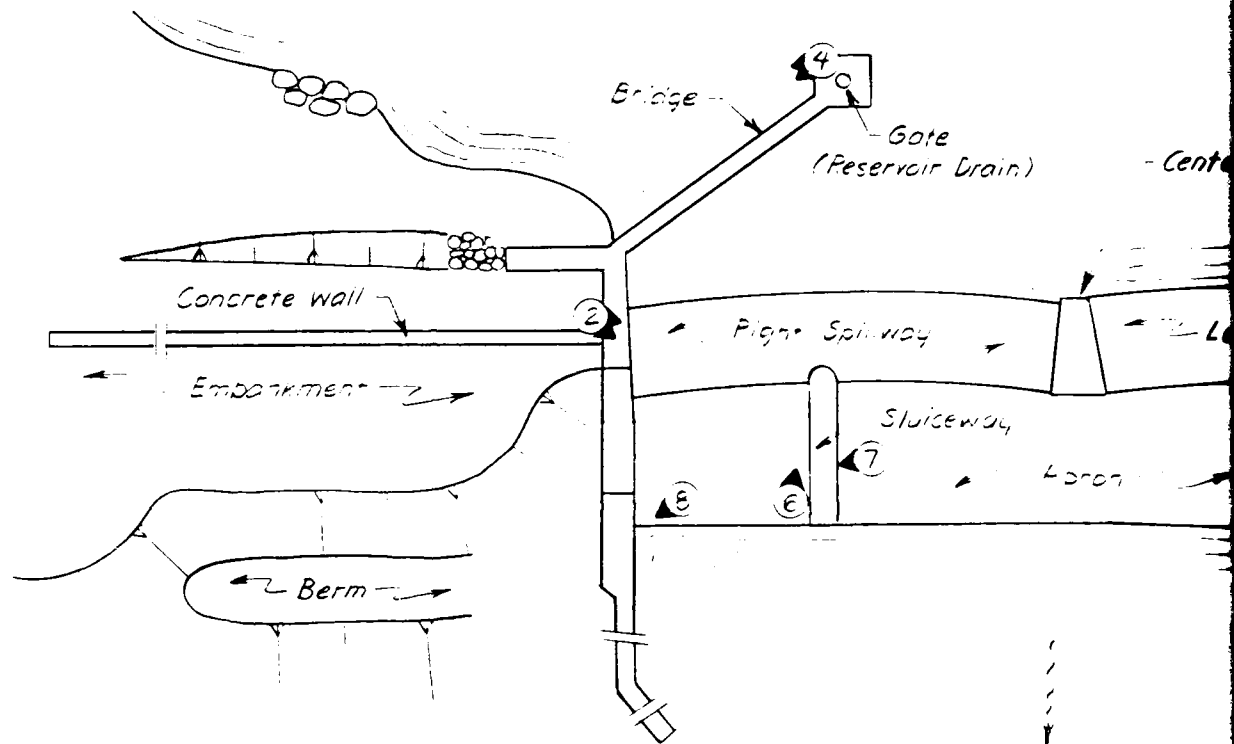
SOUTH BARRE MILL P

1. Plan sketch developed from 1944 drawing by H.M. Turner (Fig. 2) and from Haley & Aldrich, Inc. field observations.
2. See Appendix B-1 for more detailed plan and sections.
